Flood Monitoring System Assessment & Improvement Plan Development Report

Submitted by AMR Consults, LLC
to the Upper Brushy Creek Water Control
and Improvement District
February 5, 2013

Flood Monitoring System Assessment and Improvement Plan Development Report

for the Upper Brushy Creek WCID

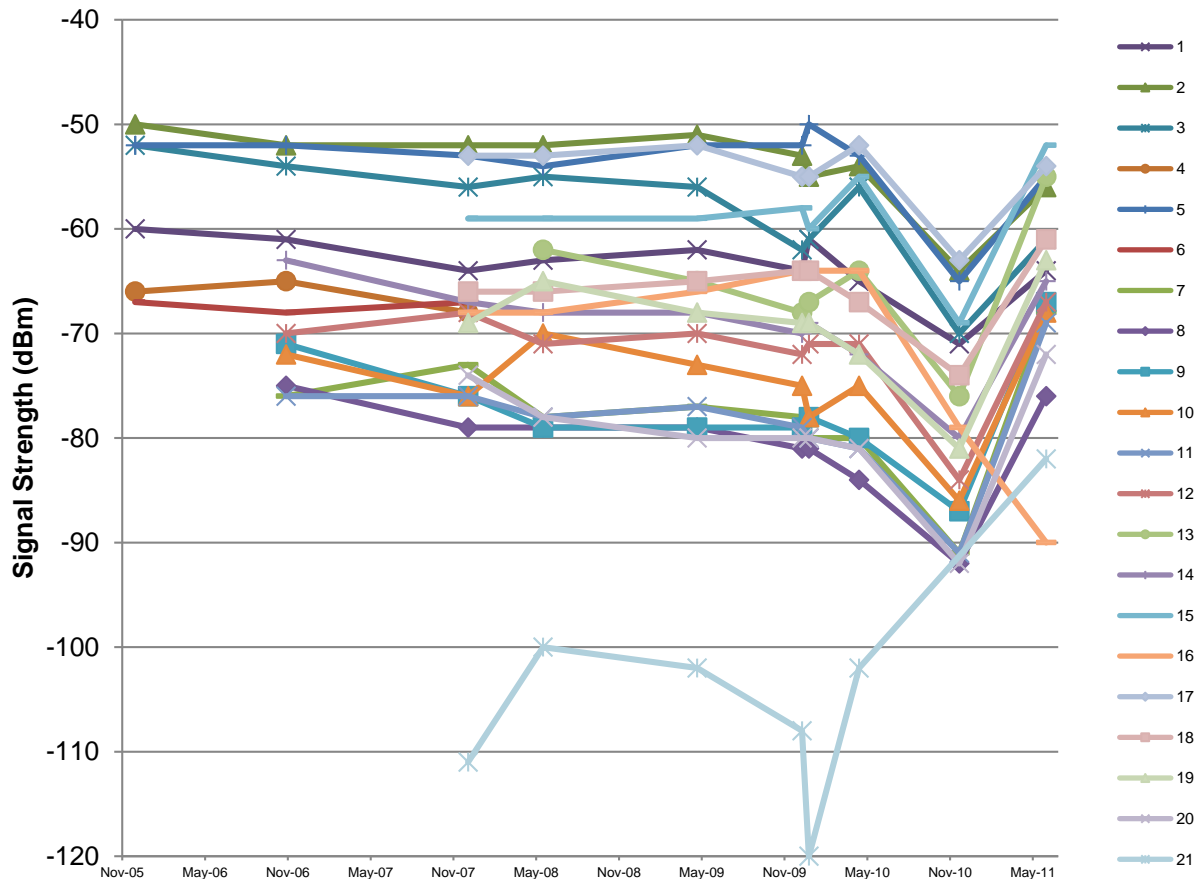
Figure 1 – RSSI Performance History

As evidenced by the dip in RSSI values in Figure 1, something happened in 2010 that caused significant degradation of the system (Tropical Storm Hermine passed through the District during September, 2010; it is possible there could have been residual impacts to communications from the storm). Then in late 2010 or early 2011 a change occurred

that resulted in an improvement that was better than the suffered loss. The only site that appears to have been operating outside a most desirable Radio path is database ID 21 (field site 22). Prior to the improvement(s) in late 2010 or early 2011, this site has operated below -100 dBm. While stations can reliably operate in this range, they do not have the fade margin to survive degradation like what happened in 2010. Yet, the improvements made brought this site back close to the -80 dBm range. Perhaps some modification in system configuration can account for the signal changes during this period.
